The Uniform Building Inspection Report™

Single Family Residence:
8885 Your Home Ave., Sacramento, CA

Inspection Date:
8/7/2006, 8:30:00 AM

Report Number:
060807.1

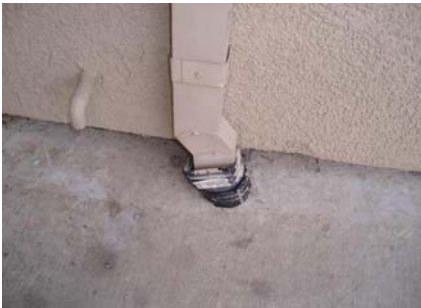
Photo: 0110.001 (1)

[P] 0110.001: Yard drains installed. It is recommended that the drains be cleaned before and during the rainy seasons.
See photo(s): 0110.001

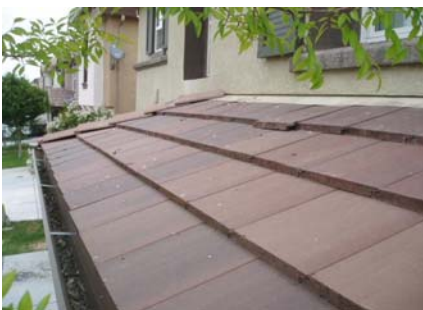
Photo: 1000.01 (1)

[P] 1000: Roof repairs / general maintenance needed.
See photo(s): 1000.01

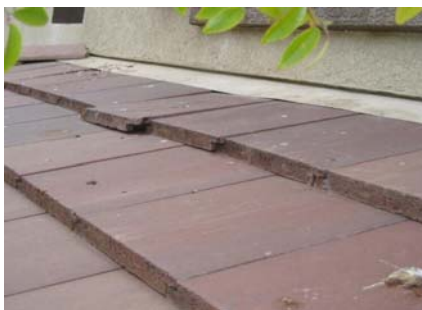
Photo: 1080.03 (1)

[P] 1080.03: Roof tiles out of position.
Noted at the front of the building.
See photo(s): 1080.03

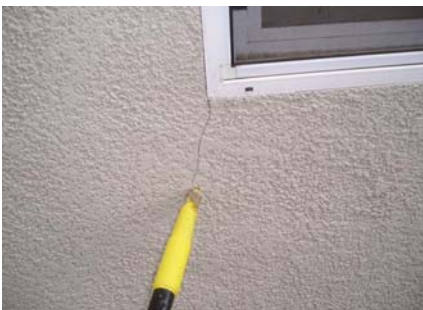
Photo: 1380 (1)

[P] 1380: Typical non-structural stucco (or exterior insulating finish system (EIFS)) cracks noted.
Any cracks may allow water to enter the wall cavity.
We recommend all cracks be caulked.
See photo(s): 1380

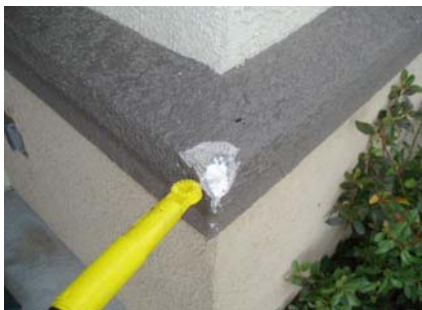
Photo: 1430.22 (1)

[D] 1430.22: Siding trim damaged. Stucco damaged in several areas. We recommend it be repaired.

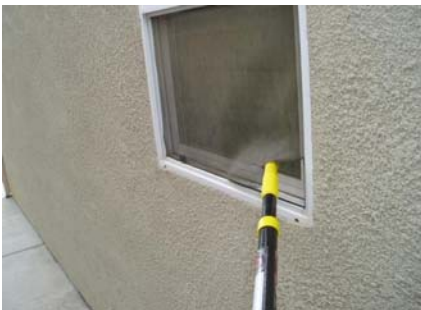
Photo: 1550 (1)

[D] 1550: Window screen(s) missing / damaged / amiss. Several

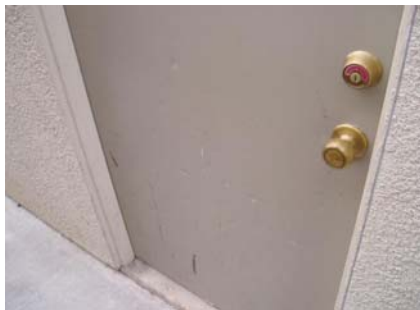
Photo: 1600.02 (1)

[A] 1600.02: Door surface damaged.

Noted at the side garage door.

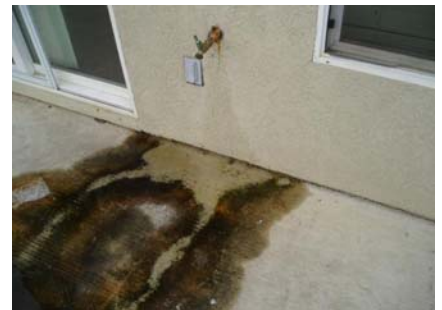
Photo: 1950 (1)

[D] 1950: Finding not covered in narratives. Water from the hose bib leak was noted coming out from the bottom of the stucco area (see arrows). The vapor barrier between the house and the stucco does not seem to be leaking at this time. A moisture meter (protimeter) was used on the interior wall and not moisture was found.

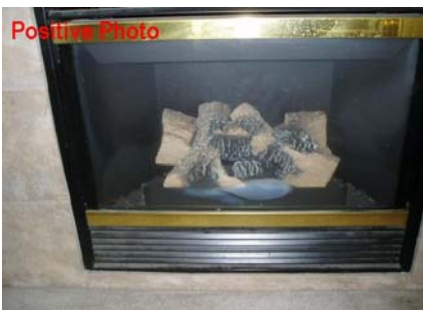
Photo: 2. Gas fireplace working. (1)

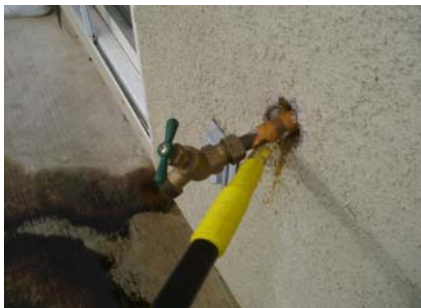
Photo: 4430 (1)

[R] [D] 4430: Water pipes or fittings leaking. We recommend this leak at the rear of the home be repaired. The water is going into the wall cavity.

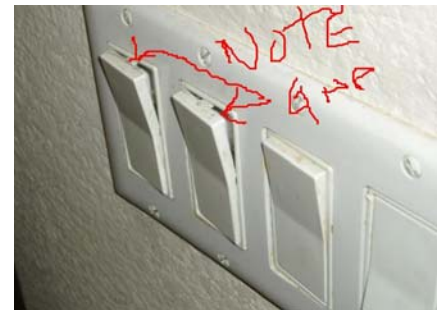
Photo: 5650.02 (1)

[D] 5650.02: Switch damaged. Several switches in various rooms were damaged. Not the gap behind the rocker switch. We recommend the switches be replaced.

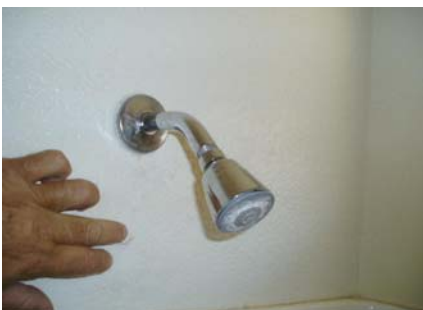
Photo: 6670.01 (1)

[D] 6670.01: Wall water damaged. Noted in the master bath This wall is soft to the touch. see termite report
See photo(s): 6670.01

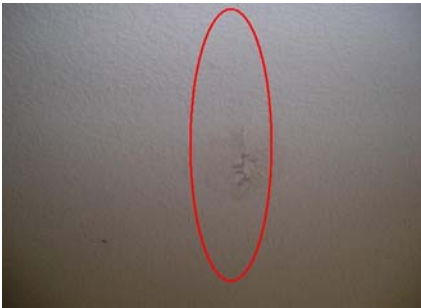
Photo: 7010.0 (1)

[D] 7010.0: Water intrusion evidence or water damage noted.

Noted in the kitchen ceiling. See termite report. Monitor for molds.

[D] 7010.0: Water intrusion evidence or water damage noted. Noted in the kitchen ceiling. See termite report. Monitor for molds.
See photo(s): 7010.0

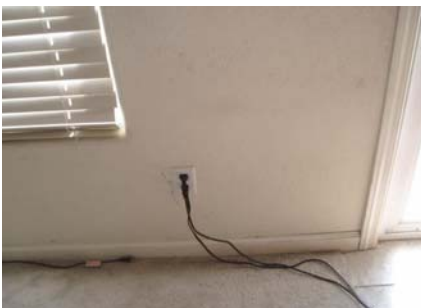
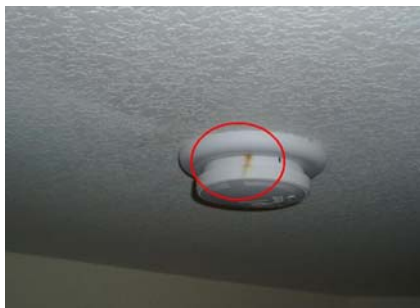
[M] 7950: Finding not covered in narratives. This is the inside wall behind the exterior water leak. The wall was dry at the time of the inspection and no water stains were noted.

[H] 7950: Finding not covered in narratives. Master bedroom smoke alarm appears to have a burn mark on its side. We recommend it be replaced.

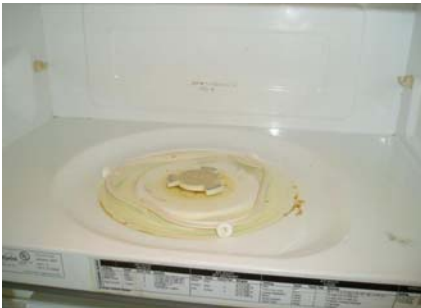
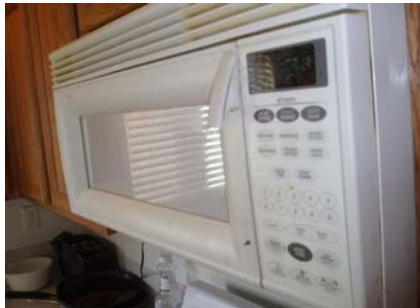
[D] 8090.02: Microwave turn table damaged. See photo(s): 8090.02

[D] 8090.02: Microwave damaged.

Handle broken and the door is damaged. We recommend the unit be replaced. See photo(s): 8090.02

[D] 8090.02: Microwave damaged. Handle broken and the door is damaged. We recommend the unit be replaced. See photo(s): 8090.02

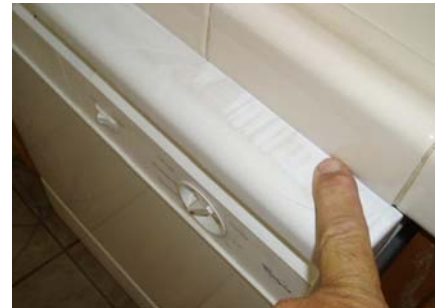
Photo: 8200.01 (1)

[D] 8200.01: Dishwasher maintenance and/or repairs needed. Dishwasher lid hits the bottom of the counter top this has caused damaged to the dishwasher. See additional photo.

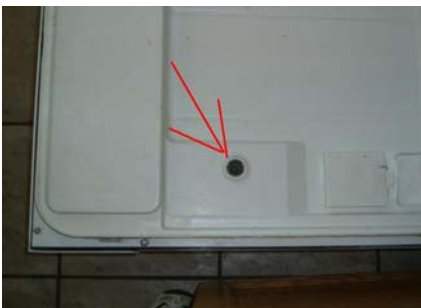
Photo: 8210.01 (1)

[N] 8210.01: Dishwasher parts missing. See photo(s): 8210.01

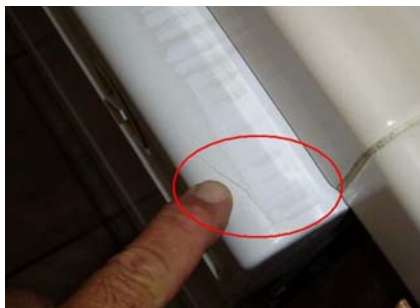
Photo: 8210.02 (1)

[D] 8210.02: Dishwasher parts damaged. See photo(s): 8210.02

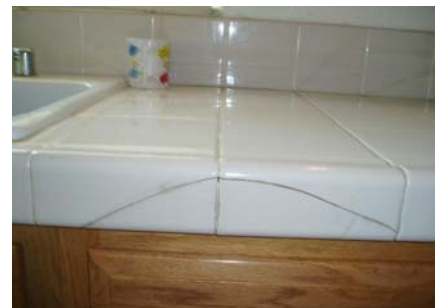
Photo: 8800.01 (1)

[N] 8800.01: Tile or grout cracked. See photo(s): 8800.01

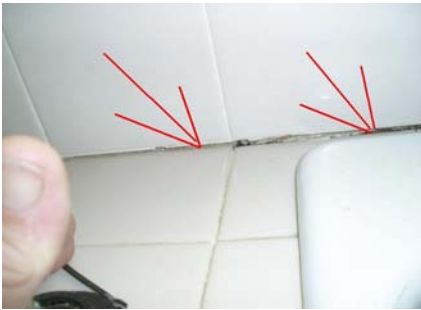
Photo: 8810.02 (1)

[R] [D] 8810.02: Countertop damaged. The grout is missing behind the sink. The counter top appears to

have not been properly supported in this area causing the counter top to bow or bend. We recommend contacting the builder or a tile contactor about this concern.

[R] [D] 8810.02: Countertop damaged. The grout is missing behind the sink. The counter top appears to have not been properly supported in this area causing the counter top to bow or bend. We recommend contacting the builder or a tile contactor about this concern.

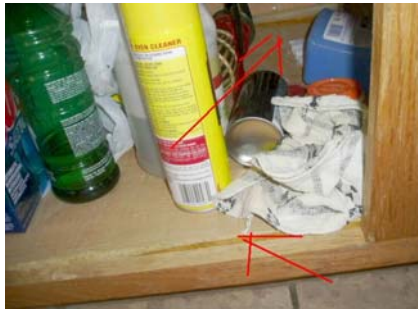
Photo: 8880.01 (1)

[D] 8880.01: Evidence of prior leaks (damage noted under sink). The shelf under the sink has swollen and is damaged. We recommend the source of the water be identified and repaired and the shelf be replaced (maybe the counter top behind the sink). See termite report
